ACTION RESEARCH: Phytoremediation of mine waste contaminated soil in coal mining area of Jaintia Hills, Meghalaya using Palmarosa [*Cymbopogon martinii* (Roxb.) Wats.]

- Project Funding: MCLLMP.
- Project Period: 1 year.

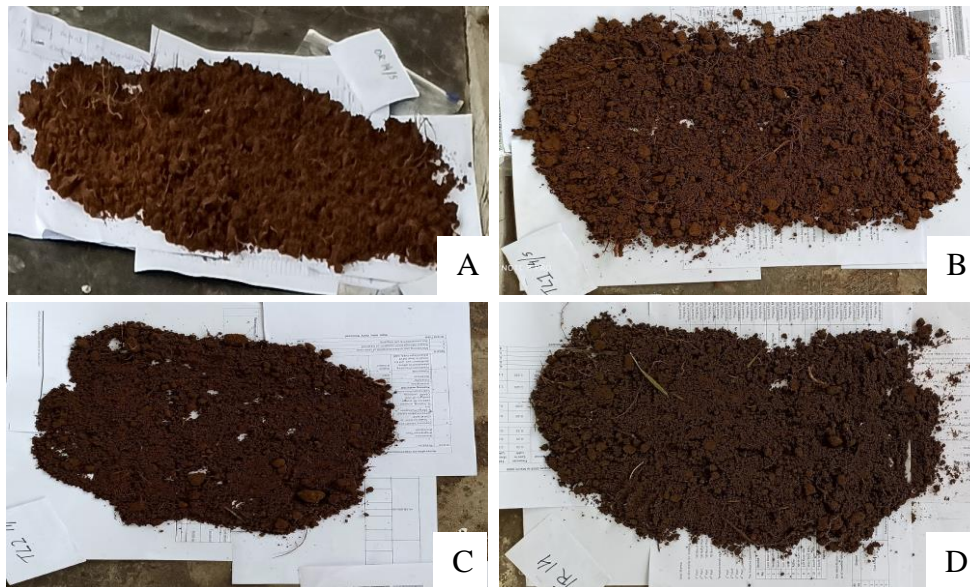
Figure: A&B: NR1 & NR2 soil samples collected from Narwan.
C&D: TL1 & TL2 soil samples collected from Tluh.

(e.) Texture: Clay in a depth of 15cm and silt in a depth of 20 cm.

(f.) Soil Colour (Indication of composition and present oxidation- reduction of soil):Hue intensity: 1-(dark brown); Brown in a depth of 15 cm; orange in a depth of 20 cm- indicates the presence of iron oxides.

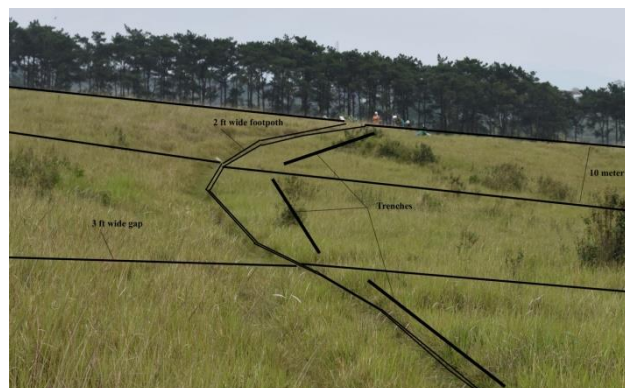
Figure.1: Layout map

The 0.80 Ha. site will be made into small plots of 10 meter(m) and each plot will be separated by a 1m wide gap for easy access like cleaning, weeding and maintenance of the plantation later after plantation. There will be a small footpath of 0.61m wide at the centre going through the field.

Due to poor water holding capacity of the soil, trenches will be dug along each of the plots. After discussion with our field engineer and surveying of the field, the trenches having a width of 0.30m and 0.61m in depth will be sufficient and the distance between two trenches down the slope can be from 50m-60m depending on the slope of the area. Rough illustration of layout is given in Figure.1

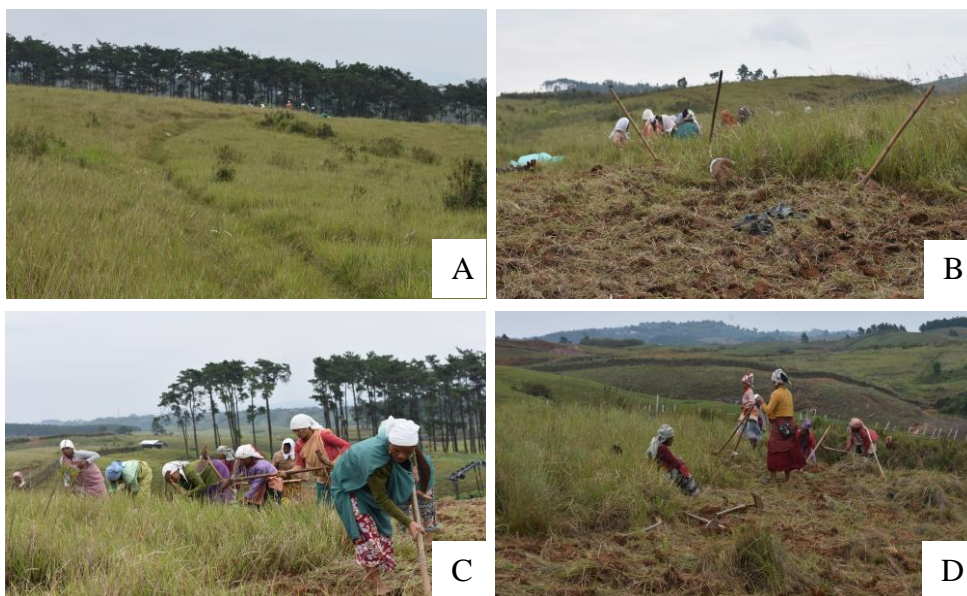
Fig.2. : A- Narwan site; B, C &D- Land development initiated from the 18/05/2020.

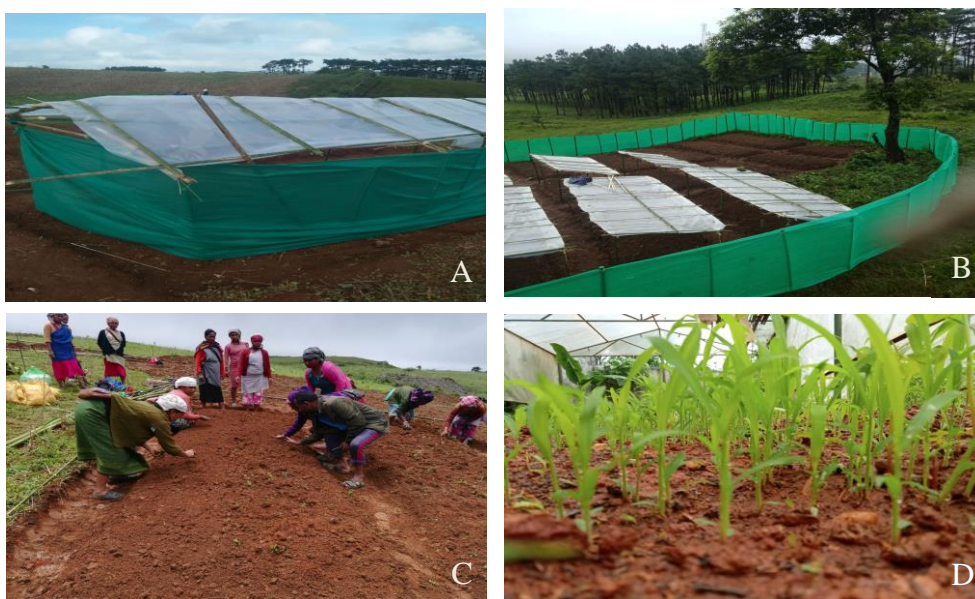
Fig 3. A.-Palmarosa nursery at Narwan. B- Palmarosa nursery at Tluh; C- Broadcast of seedsD- Palmarosa seedlings.
